FARMINGTON RIVER BASIN
TOLLAND, MASSACHUSETTS

LOST WILDERNESS LAKE
SOUTHERN DAM (TWINING POND DAM)
MA 00321

PHASE I INSPECTION REPORT
NATIONAL DAM INSPECTION PROGRAM

DECEMBER 1979

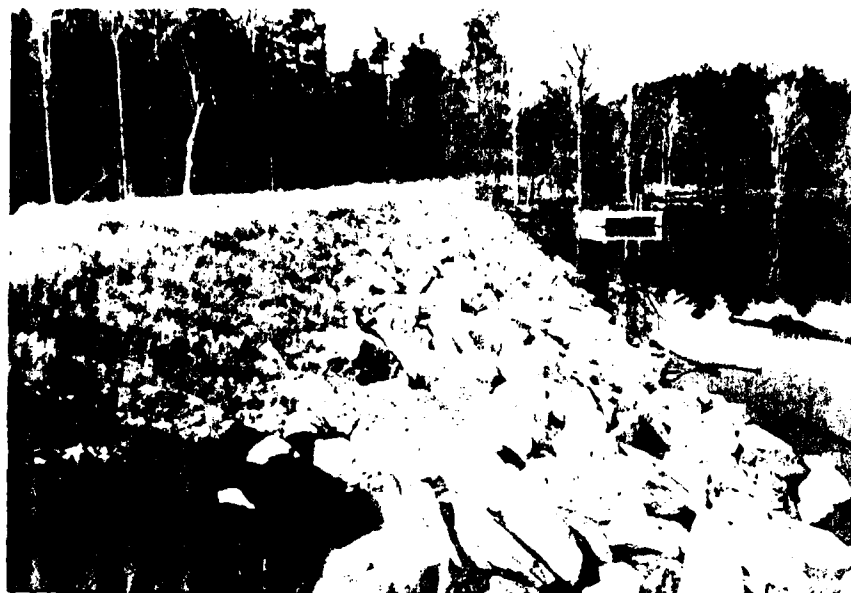
Photo 1 - Dam overview
looking westerly from
left abutment

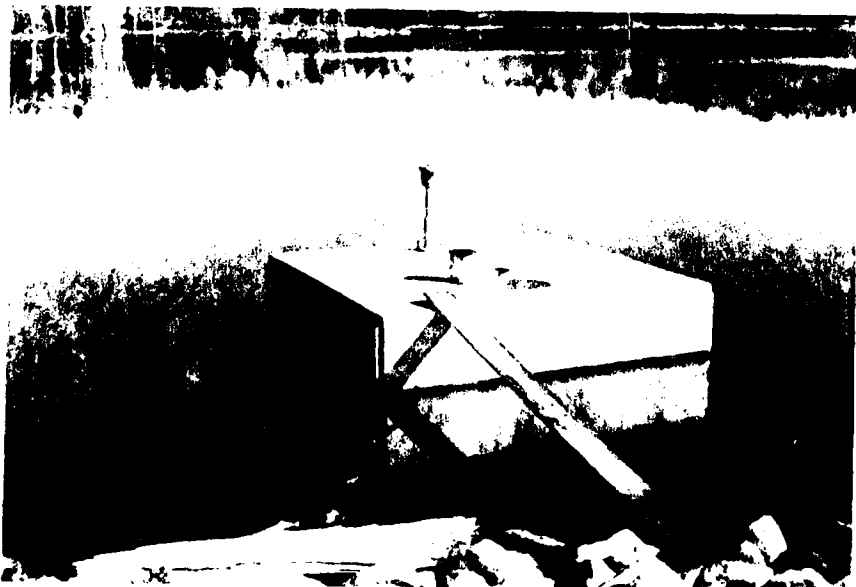
The structure is in good condition with no evidence of spalling, cracking, or efflorescence. The sluice gate bench stand is in good condition however, two base plate nuts were missing. The hand wheel has been removed from the site to prevent unauthorized use. The trash racks are in good condition and are free of debris.

Photo 3 - Principal
spillway drop inlet
riser structure

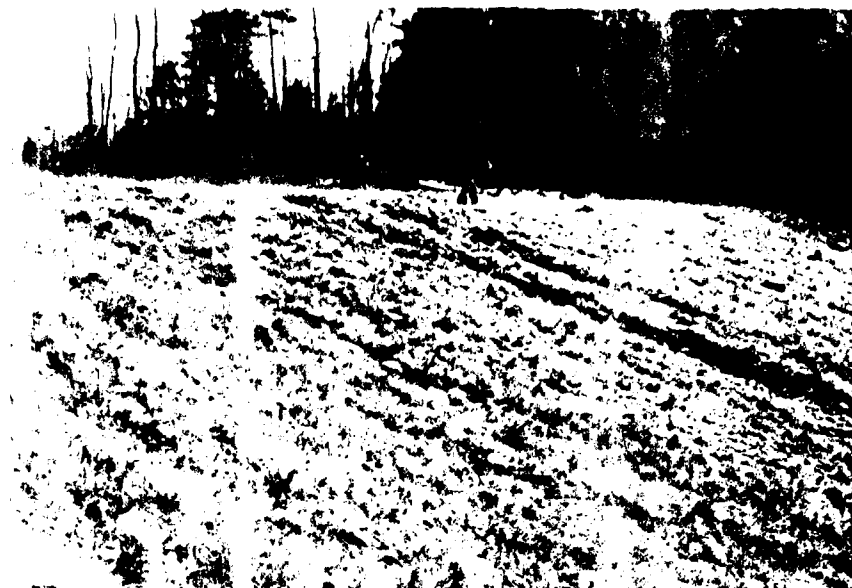
The emergency spillway is in relatively good condition. Some debris is deposited in the entrance and approach channel and the channel side slope has a ledge outcrop. There are tire marks on the downstream slope which have caused erosion. (See Photos 4 & 5.) The toe of the spillway discharge slope is wet and spongy. The area directly downstream of the emergency spillway is gently sloping and thickly wooded.

Photo 4 - View from
 top of emergency
 spillway. Note debris
 along crest section
 and erosion along
 crest and slope.
